Landslide

Introduction

Landslide events in SAARC Region during 2007

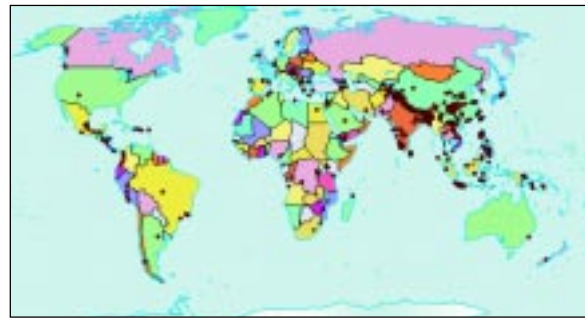
Figure 10.1: Global distribution of landslides during 2007

1.6, and Australasia 3.2) as compared to 11.27 in E. Asia and 6.77 in South Asia. In South Asia the Hindukush-Himalayan landslide belt is quite conspicuous on a global scene as per landslide events in 2007 (Figure 10.1). There is a very high concentration of landslides along the southern edge of the Himalayan chain, extending from Afghanistan through Pakistan, India, Nepal, Bhutan and Bangladesh. This belt is responsible for major landslide activity in six of the eight SAARC countries. The second concentration of landslide events can be seen along the west coast of India with in the rugged Western Ghat hill ranges. The third concentration of landslides is in the hilly areas of Sri Lanka

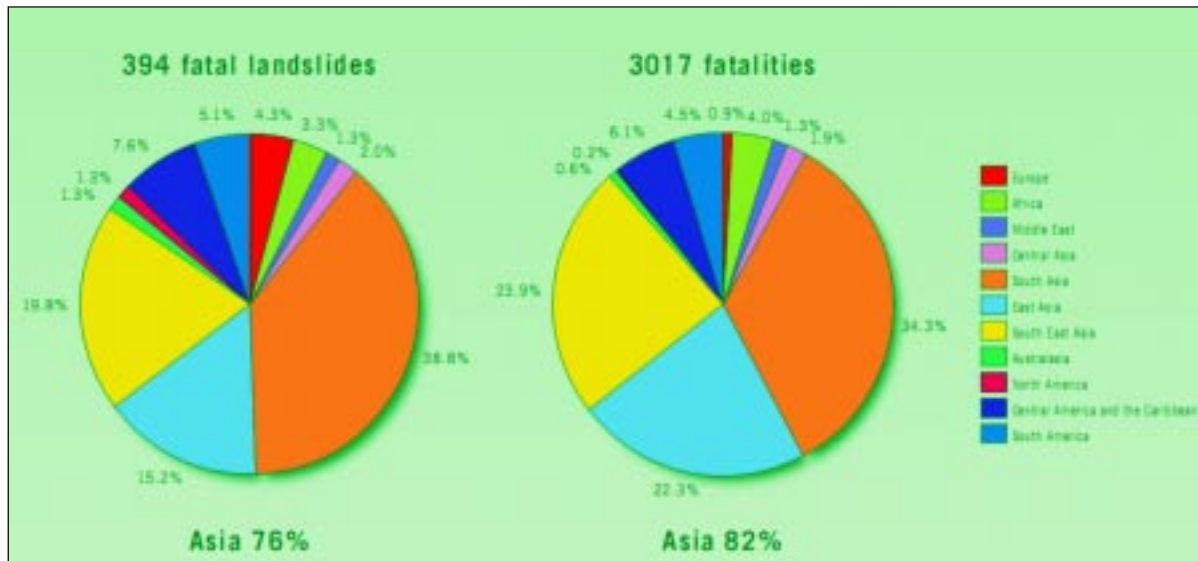
Figure 10.2: Global distribution of fatal landslides and fatalities during the year 2007. Note that the largest segment in the rose diagram (orange colour) represents South Asia

A major share of these landslides and resulting fatalities is from South Asia, which accounts for 38.8 per cent of fatal landslides and 34.3 per cent landslide deaths (Figure 10.2). It is interesting to note that in developed regions, the average of fatalities per landslide is very low (N. America 1.2, Europe

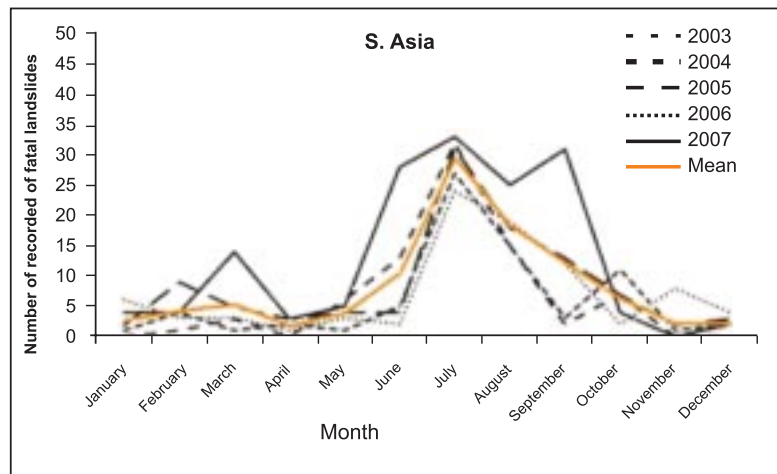
Figure 10.3: Temporal distribution of fatal landslides in South Asia from 2003 to 2007. Note that the mean shows a peak around the month of July.

anthropogenic causes, etc. are unique to each domain. The temporal occurrence of landslides with a peak in the month of July (Figure 10.3) is suggestive of their strong linkage with the meteorological phenomenon such as Asian monsoon. Hence meteorological forecasts may be useful in deducing some early warning signals about rainfall-triggered landslides in South Asia

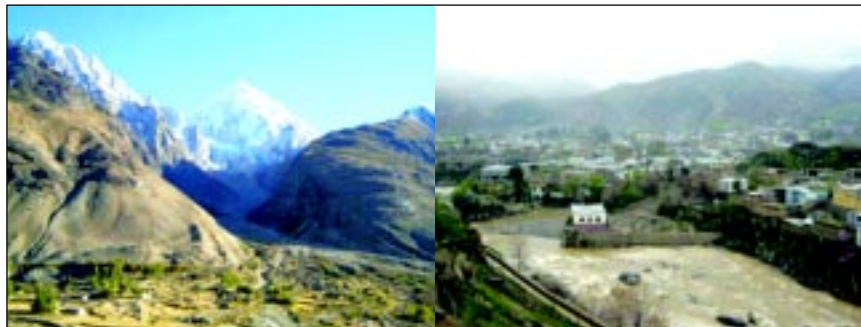
Figure 10.4: Photo on the left shows heavy snowfall which blocks access to many rural areas in Badakhshan province during winter months (IRIN). Photo on the right shows the populated unstable slopes inhabited by about 2,000 people exposed to landslide risk in Badakhshan province.

Mountainous parts of northern and northeastern Afghanistan are prone to disasters such as earthquakes, floods and landslides. Eight members of a family were killed during July 2007 when a landslide caused by melting snow hit a village in the Takhar province. During the same period, a landslide in Kunduz province, northern Afghanistan struck a wedding party and killed six children. Badakhshan province in the north-east of Afghanistan is identified as one of the most landslide-prone region wherein a joint survey conducted by the Afghan Red Crescent Society (ARCS), the UN and the provincial government found that seismic activity is widening fractures in the middle of Sia Shakh mountain in the Batash area of Faizabad city, the provincial capital of Badakhshan. This movement could dislodge large boulders, which would cause severe damage to settlements below.

Accordingly, it was recommended that all residents should be evacuated from the area as during winter, rain and snow can cause landslides that would block access to rural areas in Badakhshan's Hindukush and Pamir mountain ranges. In addition, extreme weather conditions would increase the probability of landslides and avalanches.

Though Badakhshan is sparsely populated, it is estimated that about 2,000 people in Badakhshan live in high-risk areas with respect to landslides and avalanches. These people had been advised by aid agencies and authorities to move to safer locations as the risk of being hit by landslides

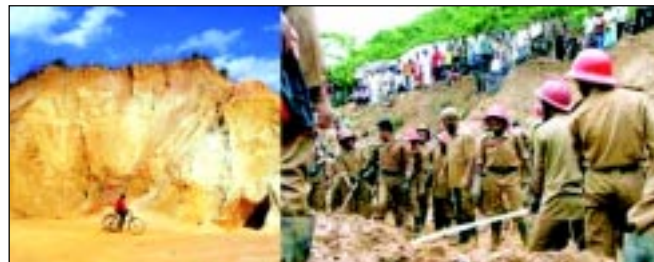
Causes of disaster: One of the immediate causes of the disaster is attributed to toe(?) cutting for making level ground required for housing despite repeated warnings from experts. The Ministry of Environment and Forest and the Chittagong Development Authority (CDA), in order to protect hill slopes, issued a circular in 2005 prohibiting hill cutting in the district. The CDA and Department of Environment filed around 100 cases in connection with hill cutting but no further steps were taken. Lalkhan Bazar, one of the worst damaged areas in the mudslide, has been identified as one of the worst affected by hill cutting. Professor of Geography and Environmental studies in Chittagong University Shahidul Islam explained, "The only reason for Monday's mud slide in the cantonment area is cutting hills indiscriminately. We were warning about this risk for decades, and this event has proved our fears." The situation was further aggravated by intense monsoon of 2007 that started with unusually heavy rain, intensified by a storm from the Bay of Bengal on June 9-10, 2007. By June 11, more than one-third of the southeastern coastal city of Chittagong was under water. Finally, the prolonged intense rain triggered devastating landslides on the deforested/barren hill slopes. In a recent

Figure 10.8: Toe cutting and removal of support of hillslopes in Chittagong city leads to massive mudslides. On the right side, the rescue workers search for bodies of landslide victims in Chittagong. Up to 8,000 people living in slums at the foothills in the port city of Chittagong will have to be rehabilitated after landslides claimed at least 91 lives in 2007

Remedial Measures: On the basis of the scientific analysis of the causes of landsliding in Chittagong, the following mitigation measures are suggested.⁷:

1. Landslide vulnerability assessment and zoning, taking into consideration different types of land use/ land cover.
2. City planning must adhere to the recommended land zoning and relevant policy and legal provisions.

3. Relocation of the foothill slums to safe places.
4. Compliance of existing legal provisions – landslide-related hazards can be reduced if hill cutting is prohibited. Where hill cutting has already taken place, sustainable structural measures may be adopted.

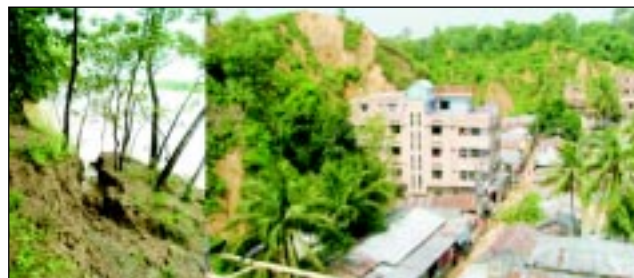
Figure 10.9: Hill slope in Khagrachhari shows early signs of collapse and a multi-storey building in high-risk zone at the bottom of a hillside in Chittagong (IRIN)

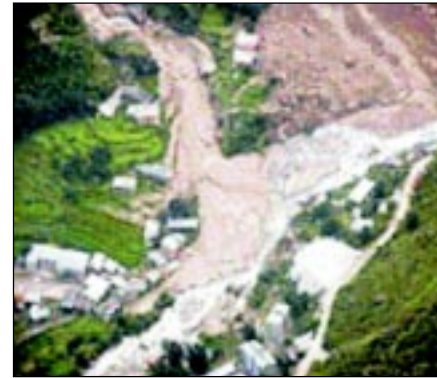
Hilly areas of Himachal Pradesh, India were devastated by a massive landslide due to intense monsoon precipitation during the first and second week of August 2007. In one catastrophic event, at least 62 people died on August 14 at Dharla village (185 km from Shimla) due to a massive landslide triggered by cloudburst in the area. The calamity struck without warning. It was a huge mass of slush and rubble that hurtled down from the heights uphill Dharla village at a terrific speed, wiping out everything that came in the way, and left a trail of misery. More than two-third of the population has perished and in most cases entire families have been wiped out. The death toll was high as people were forced to stay indoors due to heavy rain. A majority of the victims were women, schoolchildren and workers who had returned home early because of the downpour. The fact that the calamity was confined to a small area indicated that it might have been caused due to a temporary blockade of a small stream by a landslip, impounding the storm water, which suddenly gave way. The sliding mass of boulders and slush hit the village from two sides providing no time to escape.

Figure 10.10: Dharla Village landslide (Himachal Pradesh), India, that occurred during 14-15 August 2007 (Source: *Tribune*)

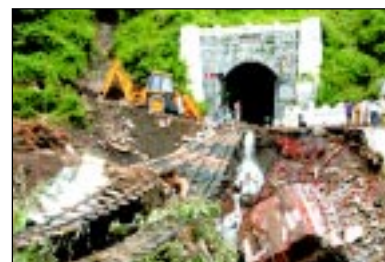
Figure 10.12: Damage to Koti railway station in Himachal Pradesh, India

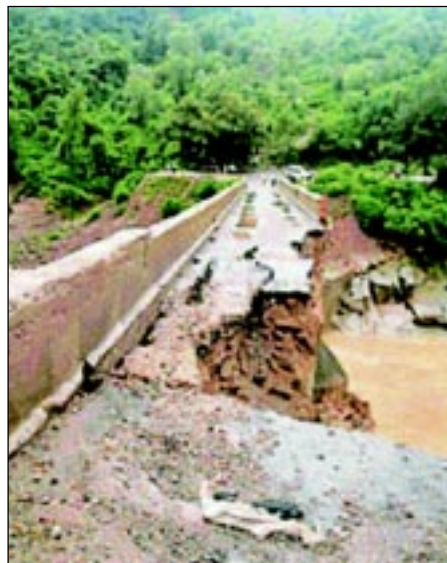
Figure 10.13: Collapse of strategic road bridge in Himachal Pradesh, India

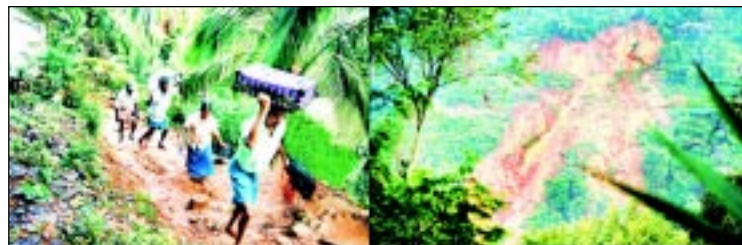
The Ritiella landslide occurred on 11 January 2007 in Walapane subdivision of Nuwara Eliya district. Nine houses were completely destroyed and 86 families were affected. Preliminary investigation reveals, this area consist of colluvium soil materials deposited by old landslides in the past. Ground shows multiple fractures mostly in the head

Figure 10.16: Following the landslides in the Walapane, Maturata and Hanguranketha areas, hundreds of villagers have fled their homes for safety. Figure on the right shows Kiriwana ella area of Walapane where five houses were buried in a landslide.

area with aperture and subsidence of few centimetres to one foot. Mudwater springs were also observed during the rainy season. Based on the field evidences, it is suggested that it is a rotational type of landslide with a much deeper slip surface.
